3-YEAR MAINTENANCE-FREE SPECIFICATION | CUSTOMIZED BOILER CLADDING

Boiler Units and Wastage Mechanisms

This Fertilizer Plant in Pakistan is operating a Cogeneration Plant to supply steam to their parent business. Boiler reliability is imperative to them.

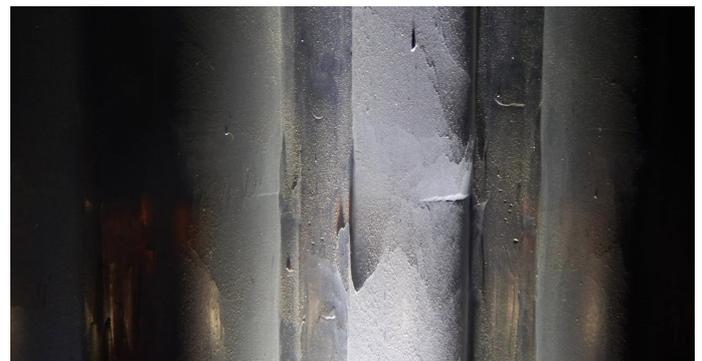
Two CFB boilers went into operation. A year after being in service, a big erosion problem was discovered, necessitating a long-term solution.

This joint will experience severe localized erosion for the life of the boiler. Tube replacement is a costly exercise. It can be 3-5 times more expensive than preventative maintenance. Moreover, the erosion is not stopped, and these costs are recurring annually.

view inside the CFB boiler - erosion damage on the membrane

This 50m² HVTS alloy cladding sample application has performed as expected and prevented any further erosion damage in that area, while the unprotected adjacent regions continued to degrade.

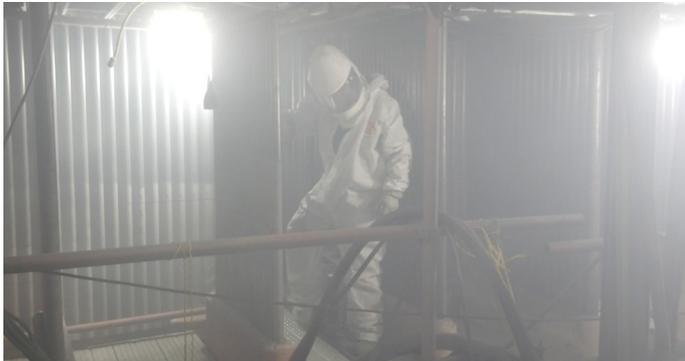
IGS HVTS technician preparing for application

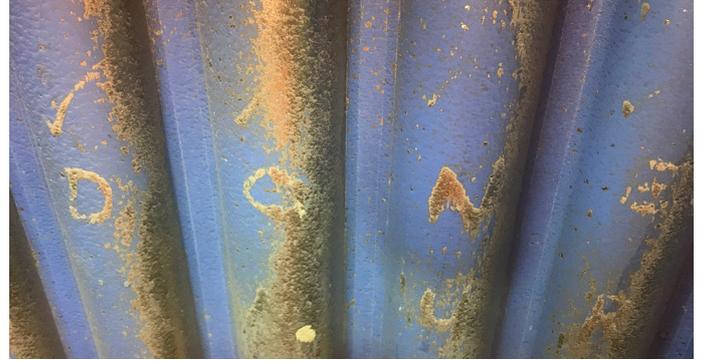
IGS inspected the HVTS alloy cladding in units 1 and 2 using exhaustive Magnetic Lift-Off (i.e., MLO), Visual Survey, and MLO SEE report. The condition of the existing cladding in both units was found to be in excellent overall condition.

IGS HVTS inspection - no remedial action required

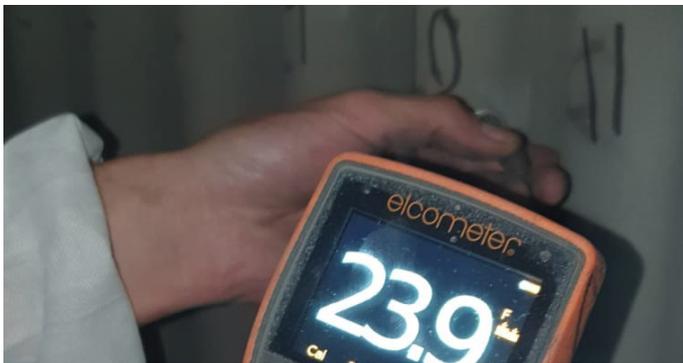
IGS HVTS thickness readings being taken

The plant asked IGS to develop a customized HVTS specification, designed to remain maintenance-free for three years. 450m² of HVTS alloy cladding was applied as part of their long-term reliability strategy. The scope was defined based on visual inspection, extensive UT data analysis, and the cladding thickness monitoring to develop a cladding thickness recommendation per erosion zone.

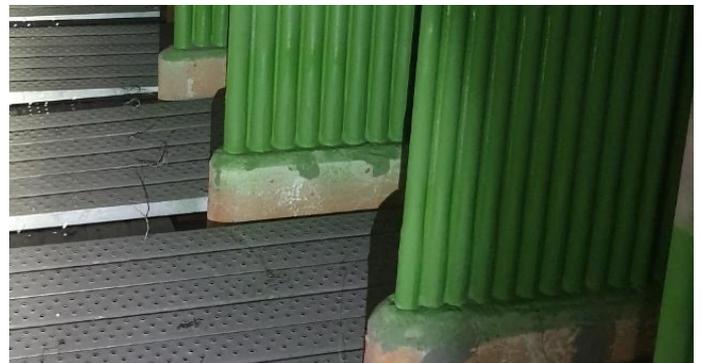
CFB Boiler panels protected with IGS HVTS
