HOW A PLANT STOPPED CFB BOILER TUBE REPAIRS | FROM 500 TO 0

Ensuring Lasting Protection Following a “One-Star” Performance by a Previous Vendor

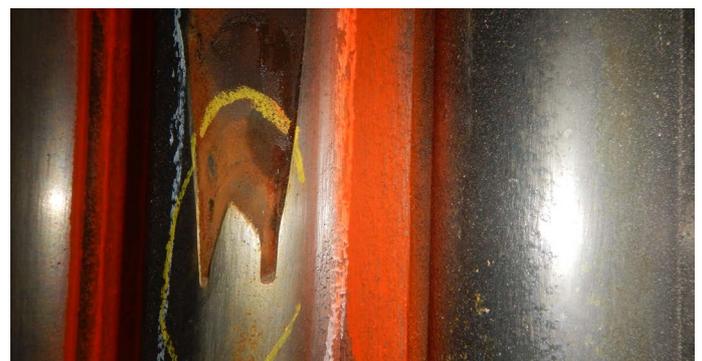
Areas that were below the minimum specification were noted and recorded. A considerable amount of the existing coating was significantly eroded. In many cases, it had worn through to the substrate and in the worst cases had allowed significant tube gouging to occur. The amount of defects observed was significantly greater than expected, with 500 tube repairs performed.

failing previously applied thermal spray cladding

- 1 Installation parameters** and low-quality surface preparation resulted in localized spalling/peeling delaminations of the other vendor's coating.
- 2 Quality control breakdown**
 - i. Failed to identify instances of poor bond integrity
 - ii. Failed to identify locations cladding was not applied to specification
 - iii. Failed to identify areas cladding was agreed to be applied, but wasn't
- 3 Inadequate cladding application procedures**
 - i. Tapered transitions
 - ii. Application to nominal thickness specifications
 - iii. Tie-ins from one cladded section to an adjacent section
- 4 Failure to set expectations** for the End-User on aspects of Cladding system ownership
 - i. Expectation of future refurbishment
 - ii. Failure to create customized specification per wear zone

- 1** IGS surveyed and mapped the problem areas.
- 2** IGS, Client, and the 3rd Party agreed on a repair procedure to include: removal of failed cladding, repeat inspection to determine severity of tube damage, mechanical tube repair, install IGS cladding installation.
- 3** IGS completed removal of the failed cladding (by means of grit blasting).
- 4** IGS, Client, and the 3rd party expert completed detailed NDT, visual, inspections to document and determine correct mechanical repair process in each location.
- 5** Client's mechanical contractor began tube repair process. IGS supported inspection efforts throughout to ensure tubes were repaired to agreed standards.
- 6** Following complete sign-off of all repairs, IGS installed new fit-for-purpose cladding system in all repaired areas.
