TUBE SUPPORT INSTALLATION DURING OPERATION

Vacuum Heater in a US Refinery

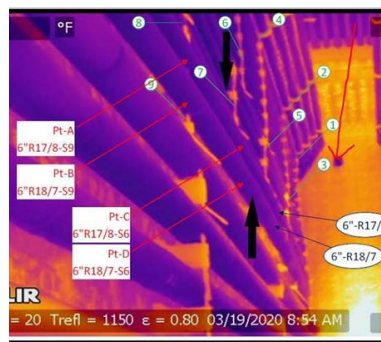
SOUTH WALL EAST DECK

PROBLEM:
Two tubes in a vacuum heater have partially lost their tube support. The retaining bar fell out of place.

1. IR image of displaced tubes

SOLUTION:
In order to prevent a potential unplanned shutdown in the future, IGS Hot-tek delivered a turnkey solution, installing tube stabilizers while the heater continued normal operation.

IGS Hot-tek supplied the tube stabilizers (manufactured out of 310 SS), and the reinforcement steel required for this project. The project was completed safely and on time in two shifts.

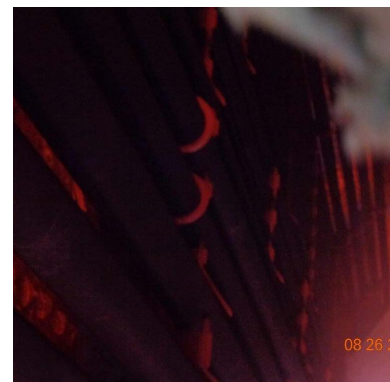
2. New tube stabilizers installed

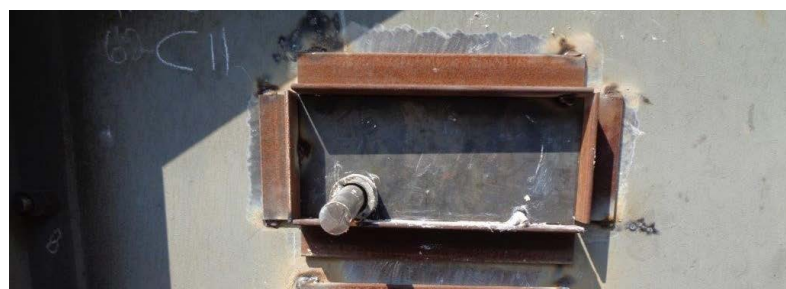
3. Tube stabilizers installed awaiting final welding (outer view)
