EXTENDING TUBE LIFE AND IMPROVING EFFICIENCY

Contact info@integratedglobal.com for more information about solutions for fired heaters and other mission critical equipment. Find your local representative by visiting integratedglobal.com

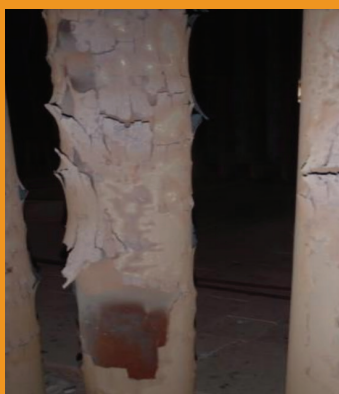
To achieve the required heat, there are four fired heaters with arbor type coil configuration that raise the feed naphtha temperature to around 545°C. The radiant tubes of the heaters are of 9Cr-1Mo (ASTM(1) A335 Gr P9) metallurgy with a maximum tube wall temperature of 652°C. The tubes are prone to excessive scaling due to high-temperature oxidation and scale thickness of up to 1-2mm were found in the tubes. The problem arising due to scaling affects not only the mechanical integrity of the radiant tubes but also leads to multiple operational constraints.

- By appearance, it typically looked like two layers of oxide scales generated out of the tube metal. Loose scales fell on the furnace floor, whereas, some tight adherent scale was still found on the tube surface.

Following a detailed root cause analysis, it was recommended to apply a ceramic coating on the radiant tube and extend it to refractory in the furnace box to improve operational and thermal efficiency, while maintaining metallurgical integrity and reliability.

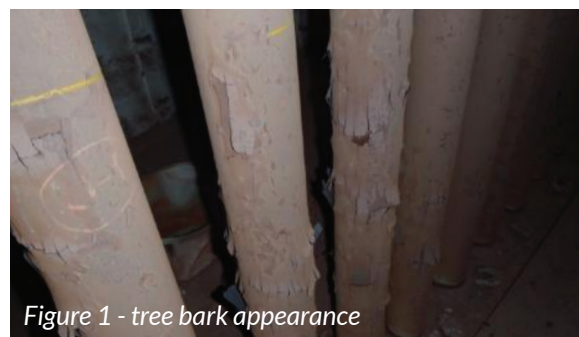
Figure 1 - tree bark appearance

- Severe scaling on the external surface of the radiant tubes with thick scales (tree bark appearance) more prevalent in the outlet tubes of the heater (Figure 1)

- Scaling was due to oxidation, which is common in these heaters considering the high operating and tube wall temperatures (Figure 2).
- Scale thickness measured were in the range of average 0.5-1mm, with some locations as high as 2mm.

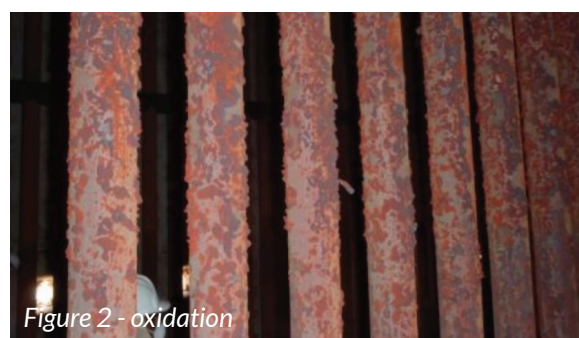
Figure 2 - oxidation

Oxidation: Severe scaling due to oxidation is expected in these heaters due to high operating temperatures. Above approximately 500 °C, the 9Cr-1Mo materials tend to oxidize and may scale very rapidly as temperatures increase. The corrosion rate based on material and temperature is around 0.25mm/year.
