HOW A PLANT STOPPED CFB BOILER TUBE REPAIRS | FROM 500 TO 0

Ensuring Lasting Protection Following a “One-Star” Performance by a Previous Vendor

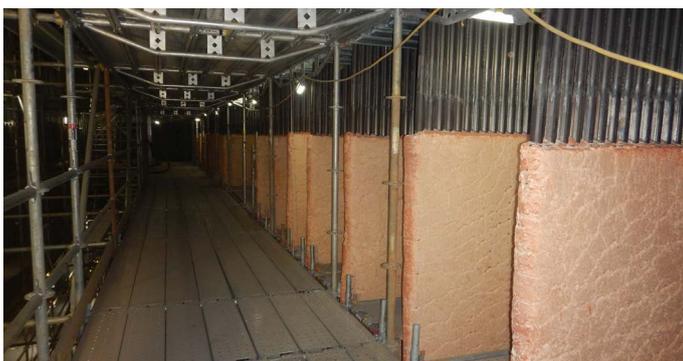
view inside the CFB boiler

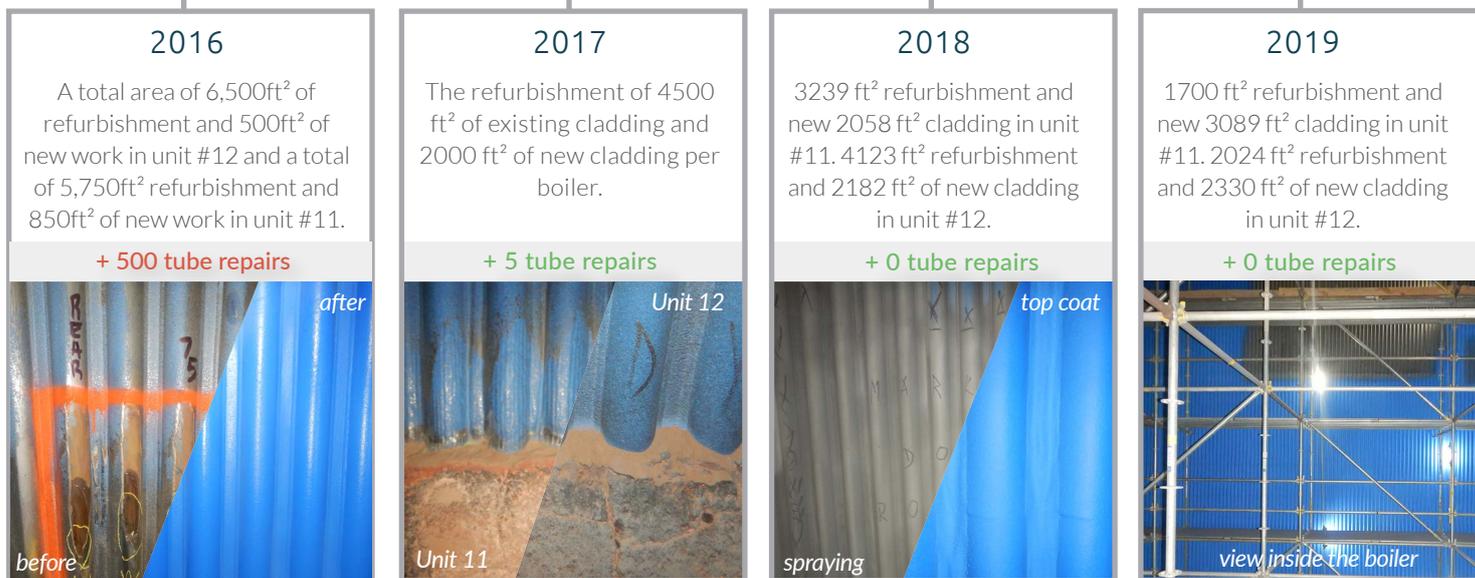
IGS Maintenance Applications Timeline at the Hybrid Energy Center

The asset owner and IGS worked closely to mitigate problems during 2016. IGS laid out a 2-year plan to stabilize the existing problems, proactively protect future problem areas, and forecast maintenance spend. The plant made investments in solving the problems the correct way and addressing wear areas proactively from Day 1.

- 1** IGS surveyed and mapped the problem areas.
- 2** IGS, Client, and the 3rd Party agreed on a repair procedure to include: removal of failed cladding, repeat inspection to determine severity of tube damage, mechanical tube repair, install IGS cladding installation.
- 3** IGS completed removal of the failed cladding (by means of grit blasting).
- 4** IGS, Client, and the 3rd party expert completed detailed NDT, visual, inspections to document and determine correct mechanical repair process in each location.
- 5** Client's mechanical contractor began tube repair process. IGS supported inspection efforts throughout to ensure tubes were repaired to agreed standards.
- 6** Following complete sign-off of all repairs, IGS installed new fit-for-purpose cladding system in all repaired areas.
